CALIFORNIA'S THIN BONDED PCC OVERLAY

1. REPORT NO. FHWA/CA/TL-83/04		2. GOVERNMENT ACCESSION NO.		3. RECIPIENT'S CATALOG NO.	
4. TITLE AND SUBTITLE CALIFORNIA'S THIN BONDED PCC OVERLAY				5. REPORT DATE June 1983

16. ABSTRACT Details of a thin bonded PCC overlay of a 17 year old PCC pavement are presented. The location was on I-80 near Truckee at 6500-7000 ft elevation. Due to the extent of bond failure, the project is considered to have "failed", and was overlaid with AC. Results of the failure investigation to date are also given.

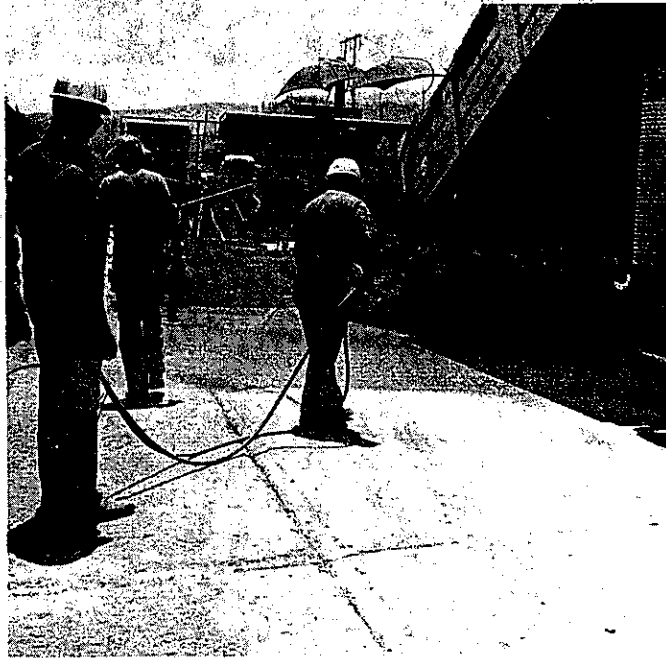
Fig. 5

A neat cement grout was specified for bonding and was supplied by a commercial pressure grouting specialist using trailer-mounted mixing and pumping equipment (Fig. 4). The selection of a spraying wand to apply the grout was based on tests conducted before the project was started (Figs. 5 and 6). The thickness of application required adjustment by trial and error. A thin coating dried before the overlay concrete could be spread over it. Average coverage for the entire project was approximately 70 sq yd per sack of cement, varying from 55 to 100 sq yd per sack. Coverage was heavier on lanes 1 and 2 at 63 sq yd per sack compared to 83 sq yd per sack on lane 3.

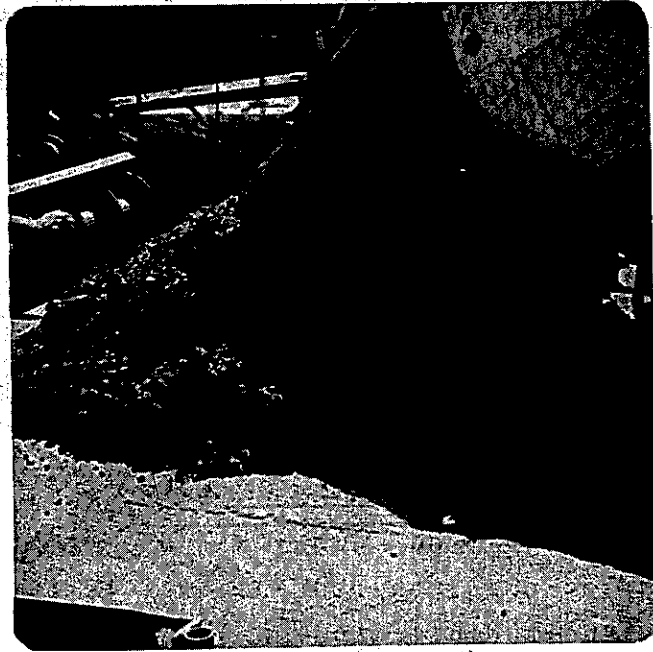
Fig. 7

Although the Contractor was experienced in slipform paving, several adjustments were required to develop a smooth paving operation. The thin overlay sections required concrete placement procedures which differed from those for normal construction. Excess concrete in front of the paver created strike off problems which resulted, at times, in loss of paver traction. This condition was aggravated by the stiff concrete used for the overlay (Fig. 7) and 5% upgrade with up to 8% cross slope.

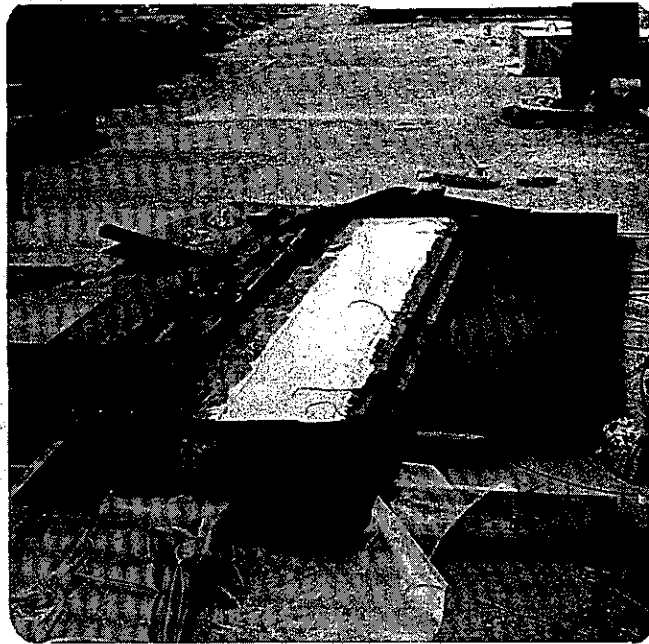
To gain more insight into mechanics of failure, a laboratory testing program was initiated. A supply of materials used on the project was obtained from the Contractor's plant. In late September, a slab 1 ft x 8 ft x 3 in. thick was cast on existing concrete using project materials, but with the grout coat brushed on rather than sprayed. The base concrete was quite smooth and was not sandblasted. Strain gages (4 inches in length) were installed both vertically and horizontally at each end of the concrete overlay (Fig. 21). Thermocouples were installed to measure temperature at the top and bottom of the overlay concrete. All gages were connected to recorders and set to print hourly readings. Fig. 22 shows the completed slab.

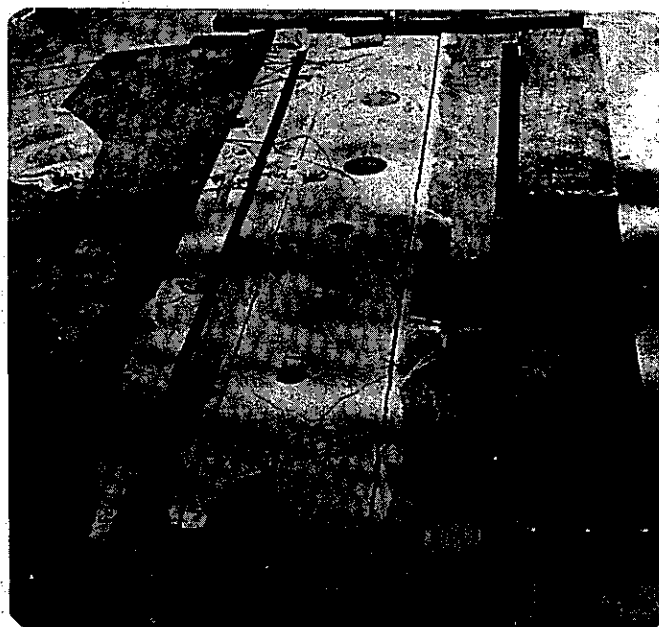
Fig. 23

Each week day morning, the ends of the slab were sounded for delamination. On the 7th day, a Monday, both ends were found to be delaminated. The area was defined as well as it could be determined. The length was about 10 inches on one end and 12 inches on the other. In another week it had progressed an additional foot. The unbonded areas were quite irregular, being considerably longer on the edges than in the center (Figs. 23 and 24).
